DOT/FAA/AR-99/87

Vertical Drop Test of a Shorts 3-30 Airplane

November 1999

Final Report

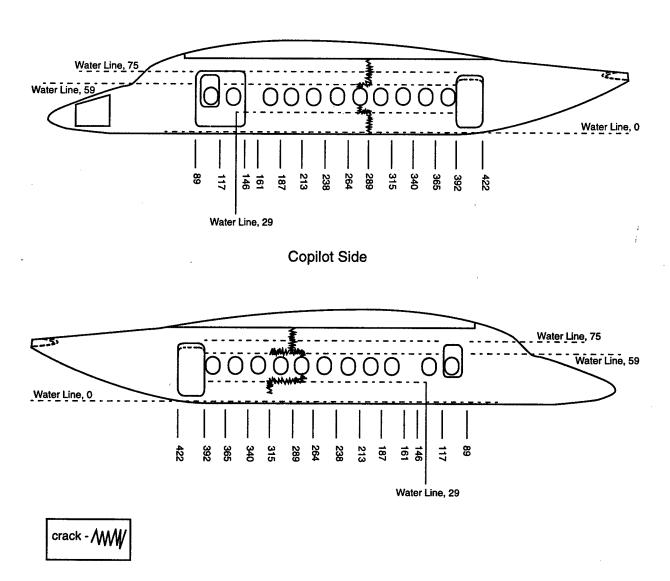
FIGURE 11. FUSELAGE CRACK

There were a number of large cracks in the fuselage skin after impact. The left side experienced a crack at FS 289 from the top of the fuselage down to the rivet line at WL 59. The crack then continued forward along the rivet line to FS 277. It then continued downward at FS 277 to the window and then on the bottom of the window down to the rivet line at WL 29. The crack then ran aft along the rivet line to FS 289. At FS 289 the crack continued downward to a point approximately 18 inches above the fuselage bottom at WL 18. The crack described above is shown schematically in figure 11.

The right side experienced a similar crack, which also is shown in figure 11. The copilot-side crack began at the top of the fuselage at FS 289. The crack ran down FS 289 to the rivet line at WL 59. At WL 59 it continued both aft and forward along the rivet line to FS 315 and FS 277, respectively. The crack then moves down along FS 277 from the WL 59 rivet line to the top of

the window at FS 277 and continues at FS 277 on the bottom of the window down to the rivet line at WL 29. The crack then continues aft along the rivet line at WL 29 from FS 277 back to FS 315. It then continues down FS 315 and ends approximately 12 inches above the bottom of the fuselage at WL 12.

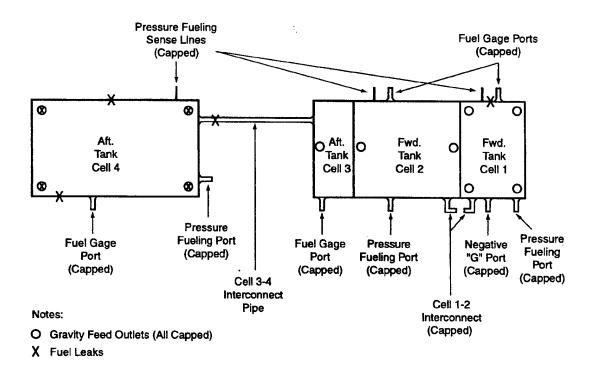
FIGURE 14. SHORTS 3-30 FUEL SYSTEM SCHEMATIC SHOWING LEAK LOCATIONS

Figure 14 shows the Shorts 3-30 fuel system schematic with damaged areas noted.

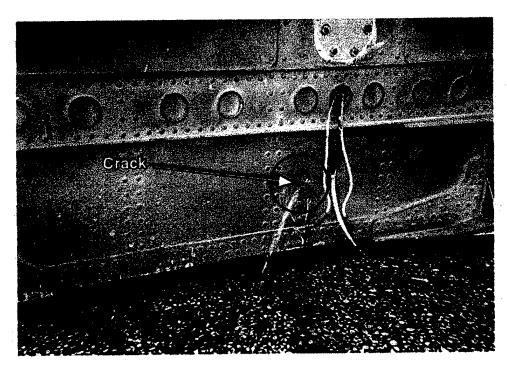
FIGURE 15. CRACK IN CELL 1 PILOT SIDE

After the test, numerous rips and tears were observed in the fuel tanks. Cell 1 experienced a crack on the pilot side of the tank, figure 15. Cell 2 experienced no leaks. Cell 3 had a massive leak through the 2-inch cell 3 to 4 interconnect pipe, figure 16. Cell 4 experienced seven leaks.

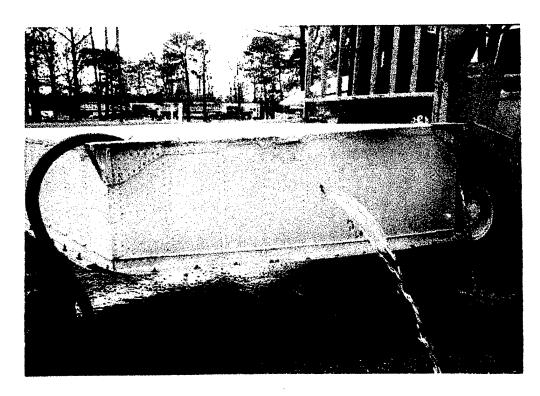
FIGURE 17. CRACK IN CELL 4 PILOT SIDE

The impact caused major cracks in both the pilot and copilot sides of the tank, figures 17 and 18, respectively. The four gravity feed outlets were crushed. Figure 19 shows typical gravity feed outlet damage. Simulated fuel also leaked from the cell 3 to 4 interconnect pipe.

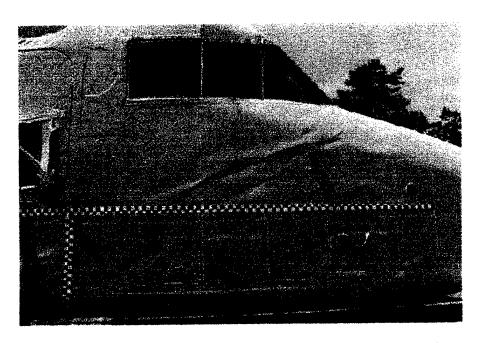
FIGURE 24. SKIN BUCKLING COPILOT-SIDE POSTTEST

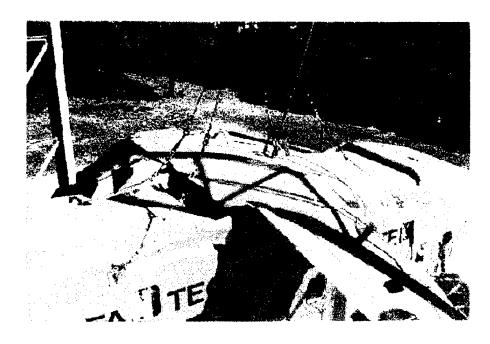
FIGURE 25. EXTERIOR FUEL TANK DEFORMATION POSTTEST

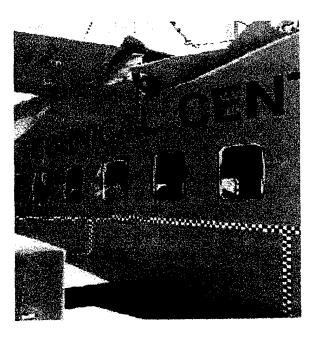
FIGURE 27. PILOT-SIDE FUSELAGE CRACK POSTTEST

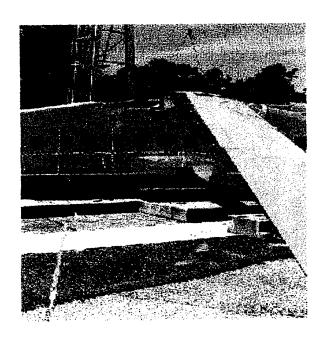
FIGURE 28. COPILOT-SIDE FUSELAGE CRACK POSTTEST

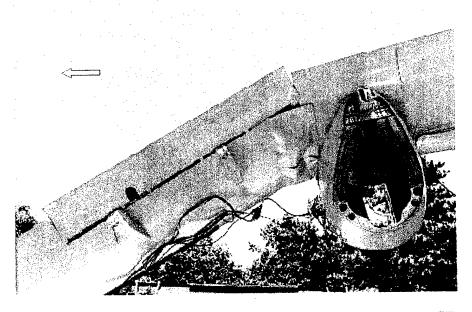
Both wings experienced major structural damage during the test. The pilot-side wing displaced downward causing a compressive failure of the wing strut. The downward deflection of the wing was so severe that the wing tip was below the bottom of the fuselage. The final position of the fuselage was elevated on a platform which allowed the movement past the bottom of the fuselage. In an actual crash the wing tips would have come in contact with the ground. In addition, the simulated engine on the pilot side broke away from its mounting.

FIGURE 29. PILOT-SIDE WING DEFORMATION POSTTEST

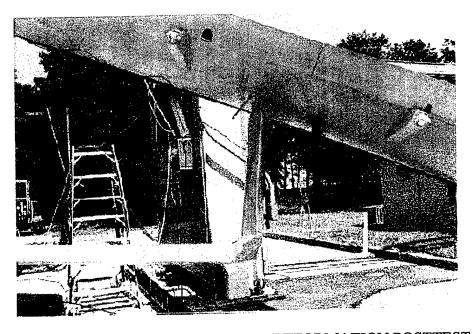
The copilot-side wing also deflected downward and experienced a similar failure of the wing strut. Again the wing tip deflected below the fuselage bottom. However, the simulated engine on this side remained attached to the engine mount.

FIGURE 30. COPILOT-SIDE STRUT DEFORMATION POSTTEST

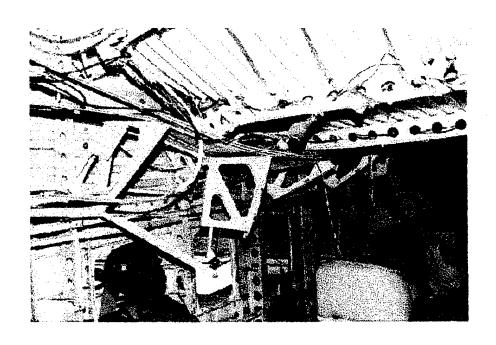
FIGURE 33. CEILING DEFORMATION POSTTEST PILOT SIDE

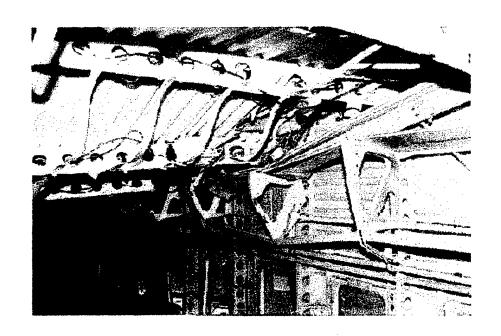
FIGURE 34. CEILING DEFORMATION POSTTEST COPILOT SIDE

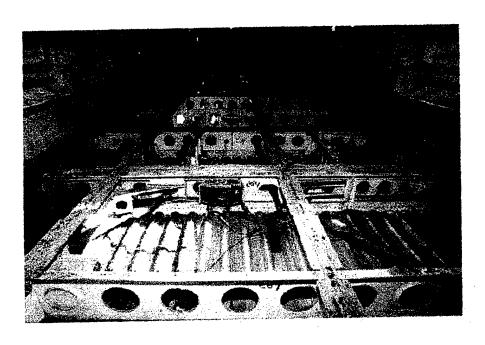
FIGURE 35. SEAT TRACK AND UNDERFLOOR POSTTEST

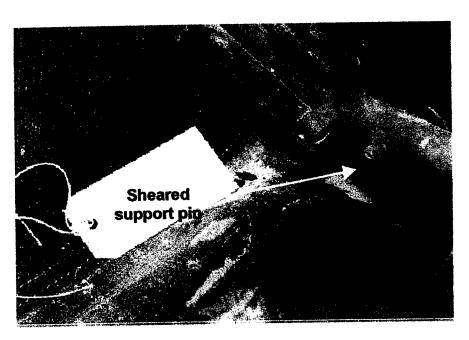
FIGURE 36. ROW 1 COPILOT-SIDE SEAT PAN

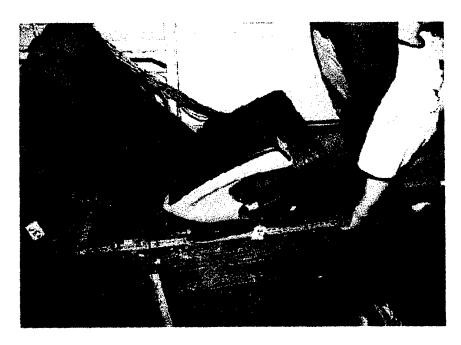
FIGURE 37. ROW 2 PILOT-SIDE SEAT LEG

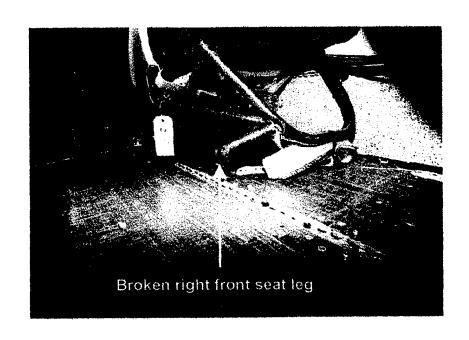
FIGURE 38. ROW 2 PILOT-SIDE SEAT LEG CLOSEUP

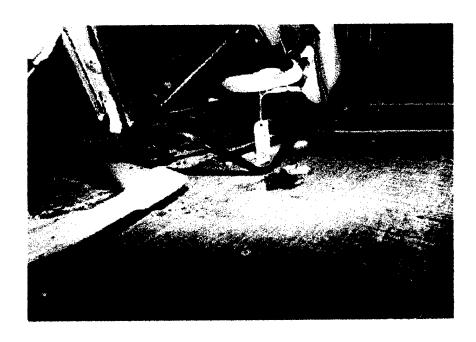
FIGURE 39. ROW 2 COPILOT-SIDE SEAT LEG

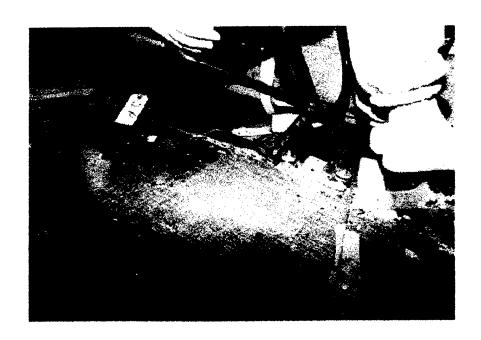
FIGURE 40. ROW 3 PILOT-SIDE SEAT LEG

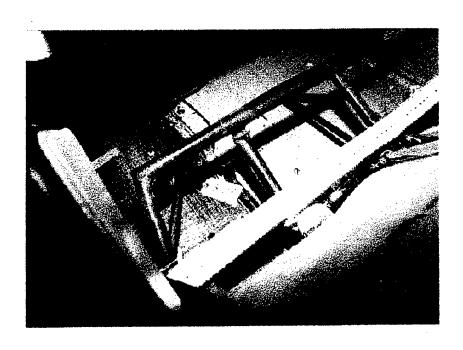
FIGURE 41. ROW 3 COPILOT-SIDE SEAT LEG

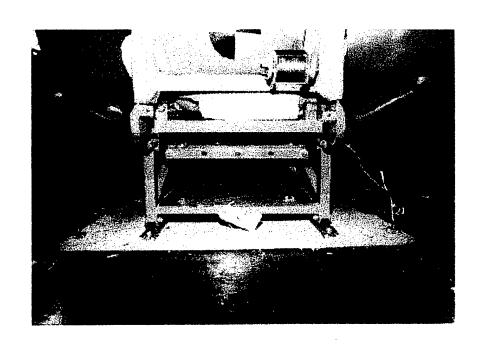
FIGURE 42. ROW 4 CAMI SEAT REAR VIEW

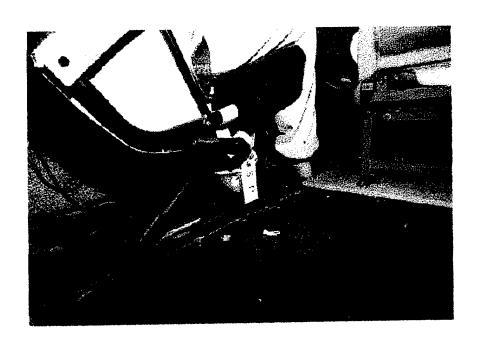
FIGURE 43. ROW 5 PILOT-SIDE SEAT LEG

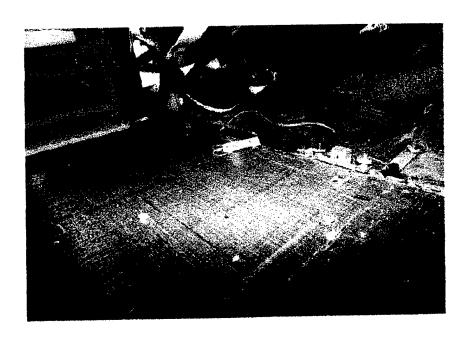
FIGURE 44. ROW 5 COPILOT-SIDE SEAT LEG

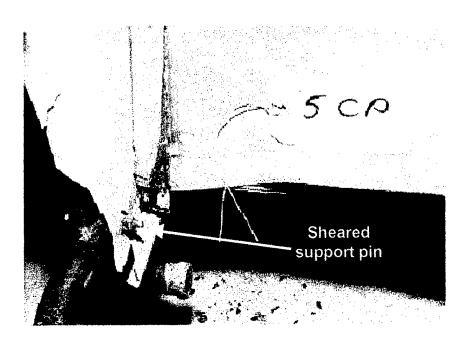
FIGURE 45. ROW 5 COPILOT-SIDE SEAT PAN

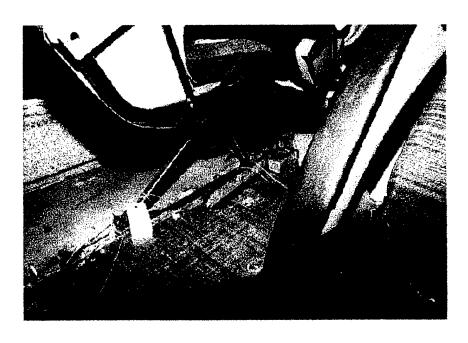
FIGURE 46. ROW 6 PILOT-SIDE SEAT LEG

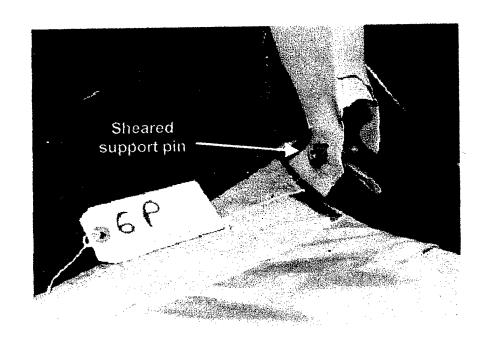
FIGURE 47. ROW 6 PILOT-SIDE SEAT PAN

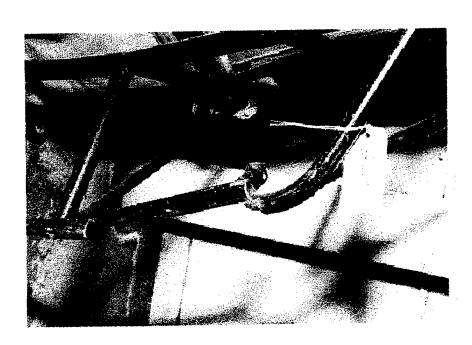
FIGURE 48. ROW 6 COPILOT-SIDE SEAT LEG

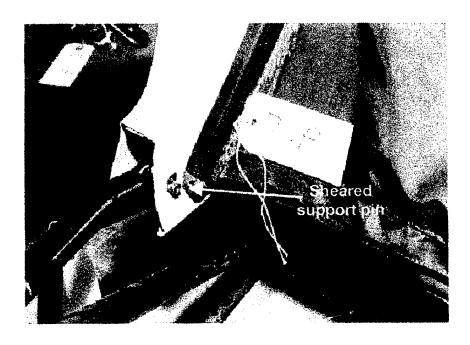
FIGURE 49. ROW 7 PILOT-SIDE SEAT PAN

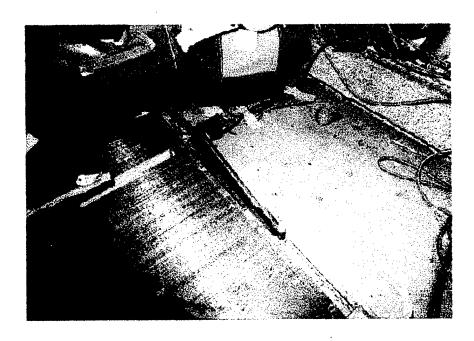
FIGURE 50. ROW 7 COPILOT-SIDE SEAT LEG

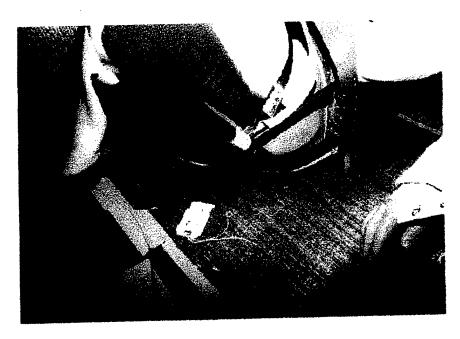
FIGURE 51. ROW 7 COPILOT-SIDE SEAT LEG CLOSEUP

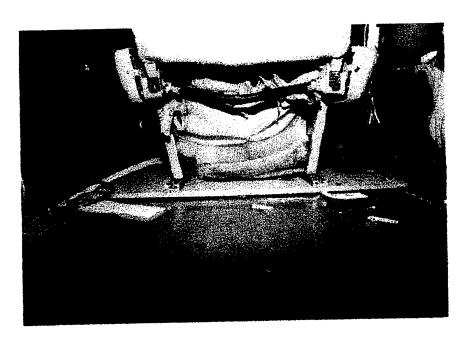
FIGURE 52. ROW 8 BEECHCRAFT SEAT REAR VIEW

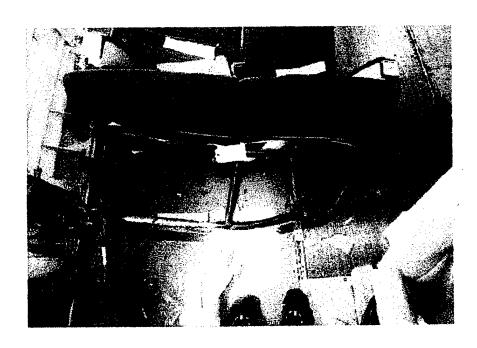
FIGURE 53. ROW 9 COPILOT-SIDE SEAT LEG

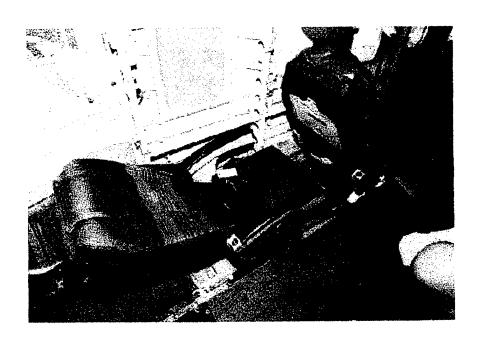
Seat back damage (i.e., excessive reclining) was minimal, mainly because the seat backs were supported by the legs of the occupants in the seats behind them. The seats in the last row, row 10, saw significant deformation as there was nothing behind them to stop their movement.

FIGURE 54. ROW 10 PILOT-SIDE SEAT BACK

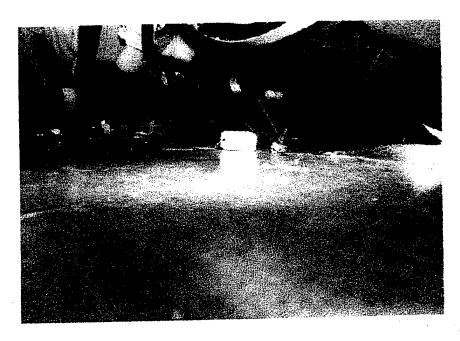
FIGURE 55. ROW 10 COPILOT-SIDE SEAT LEG

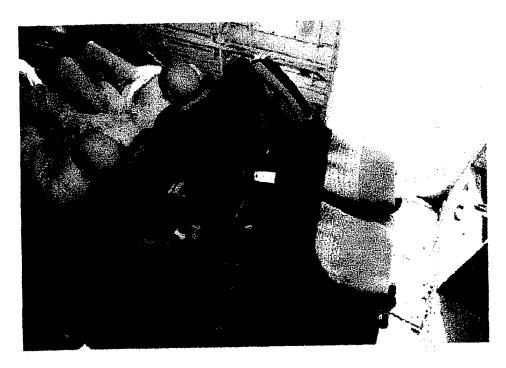
FIGURE 56. ROW 10 COPILOT-SIDE SEAT BACK

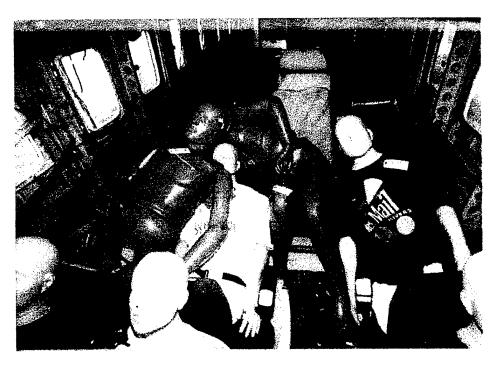
The stroking mechanism in the CAMI seat (row 4) failed to function properly. The lack of stroking resulted in higher than expected pelvic loads.

FIGURE 62. ROW 4 ATD POSTTEST FRONT VIEW

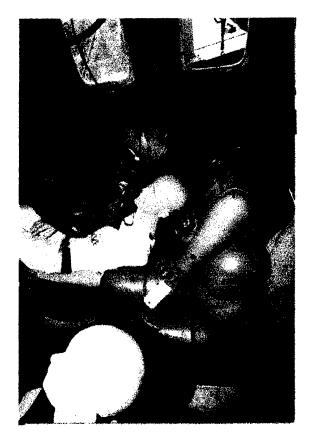
FIGURE 63. ROW 4 ATD POSTTEST SIDE VIEW

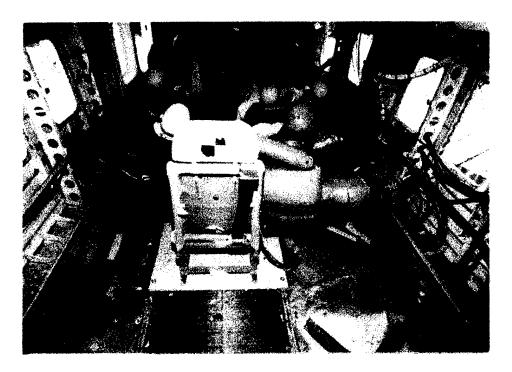
FIGURE 64. ROW 4 ATD POSTTEST AFT VIEW
